DEPARTMENT OF TRANSPORTATION**DIVISION OF ENGINEERING SERVICES**

Contract #: 04-0120F4Cty: SF/ALA Rte: 80 PM: 13.2/13.9File #: 69.28**WELDING INSPECTION REPORT****Resident Engineer:**Siegenthaler, Peter**Address:** 333 Burma Road**City:** Oakland, CA 94607**Report No:** WIR-022132**Date Inspected:** 24-Mar-2011**Project Name:** SAS Superstructure**OSM Arrival Time:** 700**Prime Contractor:** American Bridge/Fluor Enterprises, a JV**OSM Departure Time:** 1900**Contractor:** Zhenhua Port Machinery Company, Ltd (ZPMC), Changxing Island **Location:** Shanghai, China**CWI Name:** Li Yang**CWI Present:** Yes No**Inspected CWI report:** Yes No N/A**Rod Oven in Use:** Yes No N/A**Electrode to specification:** Yes No N/A**Weld Procedures Followed:** Yes No N/A**Qualified Welders:** Yes No N/A**Verified Joint Fit-up:** Yes No N/A**Approved Drawings:** Yes No N/A**Approved WPS:** Yes No N/A**Delayed / Cancelled:** Yes No N/A**Bridge No:** 34-0006**Component:** Orthotropic Box Girder(OBG)**Summary of Items Observed:**

OBG # TRIAL ASSEMBLY YARD**WELDING:****Cross Beam 17**

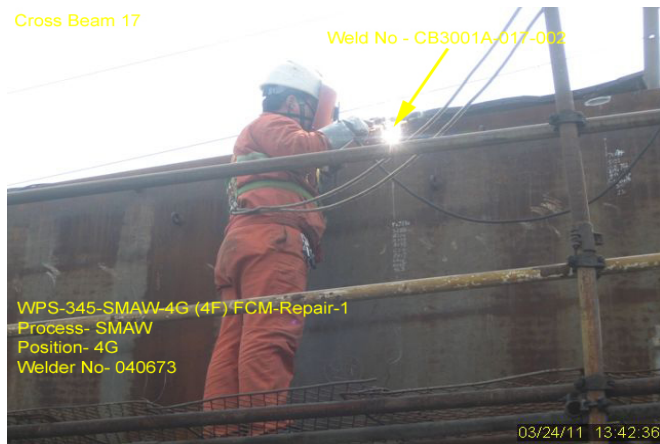
This QA Inspector observed ZPMC qualified welding personnel identified as 040673 perform Shielded Metal Arc Welding (SMAW), weld joint identified as CB3001A-017-002; located On Orthotropic Box Girder (OBG) Deck Plate to Side Plate CJP Weld; ZPMC Quality Control (QC) is identified as Mr. Li Yang. This QA Inspector observed the base material appears to have been preheated by an electrical heating element prior to welding. The Welding Repair Report (WRR) was B-WR20402. ZPMC Quality Control (QC) Mr. Li Yang was onsite monitoring the welding variables. The welding variables recorded by QC appeared to comply with applicable WPS-345-SMAW-4G (4F) FCM-Repair-1. See attached photo for further details.

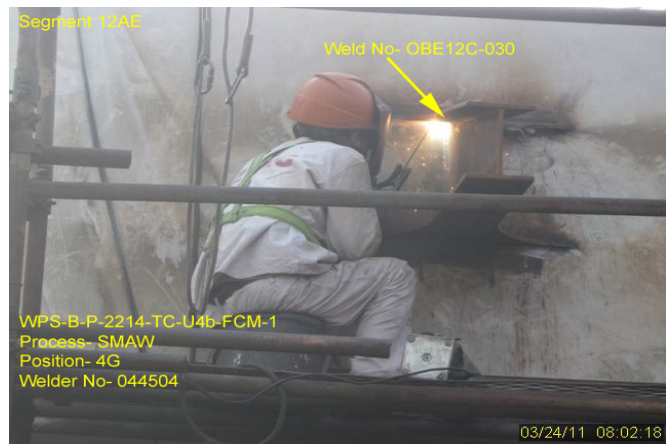
Welding (SMAW), weld joint identified as OBE12C-029; located On Orthotropic Box Girder (OBG) Edge Plate to Cantilever Bracket Fillet Weld; ZPMC Quality Control (QC) is identified as Mr. Wang Li Yang . This QA Inspector observed the base material appears to have been preheated by a torch prior to welding. ZPMC Quality Control (QC) Mr. Wang Li Yang was onsite monitoring the welding variables. The welding variables recorded by QC appeared to comply with applicable WPS-B-P-2214-TC-U4b-FCM-1. See attached photo for further details.
